Better Buildings

• BUILDING ENVELOPE SERIES •

Project: High-Rise Masonry Wall Rehabilitation

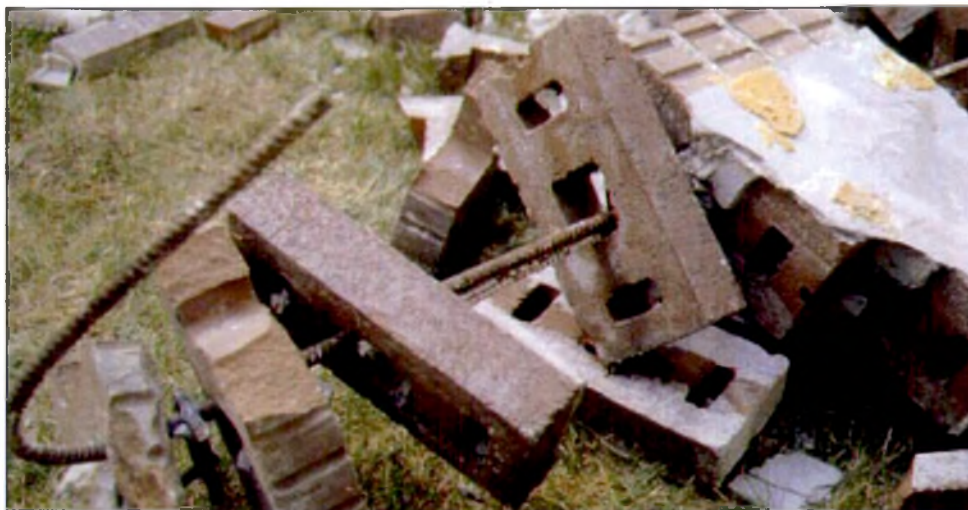
In 1991, a 12-storey, 177-unit condominium in Ottawa, Ontario ran into trouble when the bottom two storeys of a masonry wall section collapsed (photo 1). The primary objectives of the project were to prevent further collapse, to protect safety and to prevent liability. Secondary objectives included the elimination of troublesome water leakage, improvement of occupancy comfort and the minimization of future repair costs.

1. The masonry wall system was not horizontally reinforced.
2. A covermeter survey and the opening of walls at various points revealed that the vertical reinforcement was poorly spaced and grouted and significantly corroded.
3. The vertical reinforcement was seldom connected to the floor slabs.
4. The brick overhang at the slab edges exceeded specified dimensions.
5. Through-wall flashings had been installed but no weep holes.
6. The adhesive between the insulation and masonry was largely ineffective.
7. Soft joints had not been installed consistently to allow for differential movement between the concrete structure and masonry.
8. The queen closer units had not been secured to the floor slab structure.

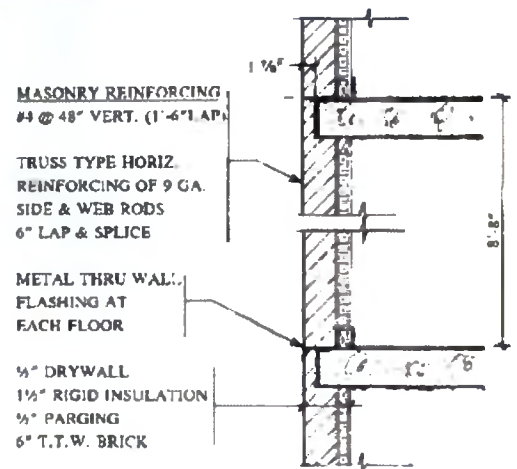
Detail 1

The original wall assembly consisted of 150-mm TTW clay bricks, 12-mm parging, 38-mm expanded polystyrene insulation and 12-mm drywall (detail 1). The brick walls were supported directly at each floor level. A queen closer unit covered floor slabs to give the appearance of a continuous brick veneer. Vertical strips of window-insulated metal spandel panels divided the masonry walls into vertical sections ranging from 1 m to 4 m in width.
