Better Buildings

Envelope and Accessibility Retrofits

Bashaw Senior's Lodge

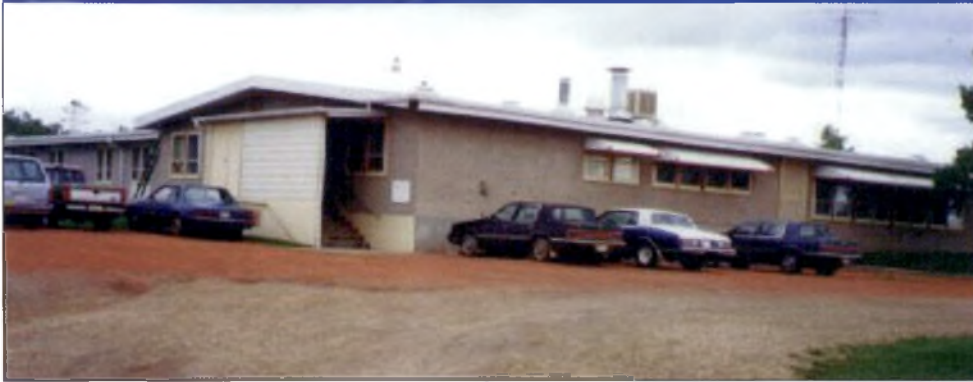
North-West corner (before renovation)

1. There were complaints of cold exterior walls and drafts. The owners had already strapped, insulated and added a stucco finish on the north-west wall in 1987 to alleviate a local problem, but complaints persisted in other areas. Test holes were made in the exterior walls to determine insulation type, vapour barrier type, and whether there were condensation or other moisture problems. The existing wall had 3" batt insulation, poly vapour barrier and no evidence of moisture problems.

A two-component spray-in-place polyurethane insulation, 75mm thick was applied to the existing walls. This continuous insulation system provides an air barrier and vapour retarder because it flows into cracks and gaps and around protrusions and is completely seamless. No caulking was involved and other trades were not disrupted.

The exterior wall was strapped with 38 mm x 38 mm wood strapping at 400 mm horizontally and 38 mm deep “Z” bars at 400 mm vertically to minimize thermal bridging. Plywood sheathing (9 mm), building paper, a metal lath and a new stucco finish were applied. This increased the thermal resistance of the wall from 1.93 RSI (R-11) to 5.28 RSI (R-30).

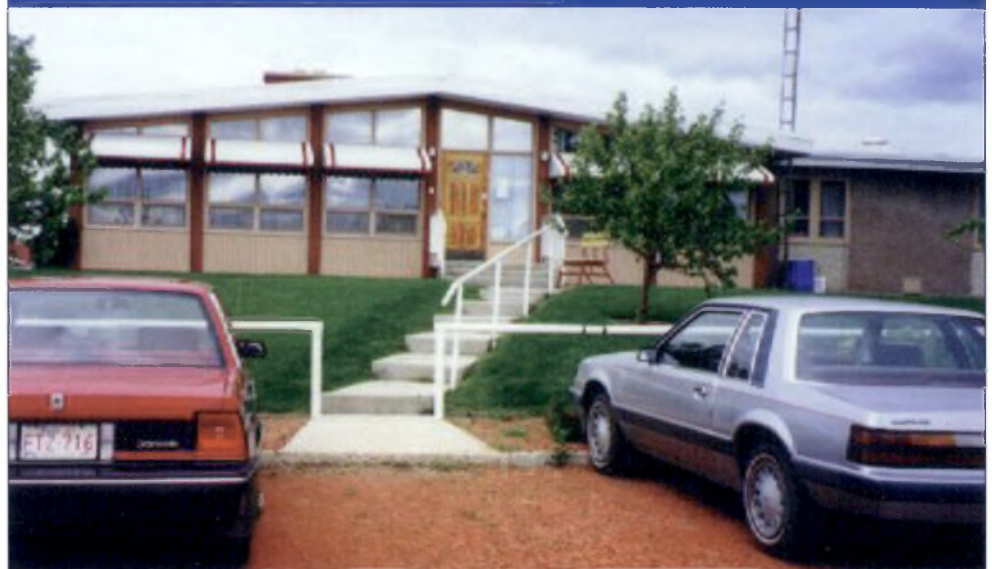
Main entrance from parking lot (before renovation)

1. The ramps providing access to the building were not in compliance with the Alberta Building Code. The slope was too steep and the guardrails too low.
2. Main entry was not barrier free.

The objectives of the work were to increase access, safety and comfort for the residents. Barrier-free access was increased by providing a ramp and new entry doors with an electronic opener, and by renovating the public washroom and two of the resident suites so they would be suitable for wheelchair use.
