BETTER BUILDINGS

58 Lakeview, Timmins, Ontario

CASE STUDY NUMBER 5

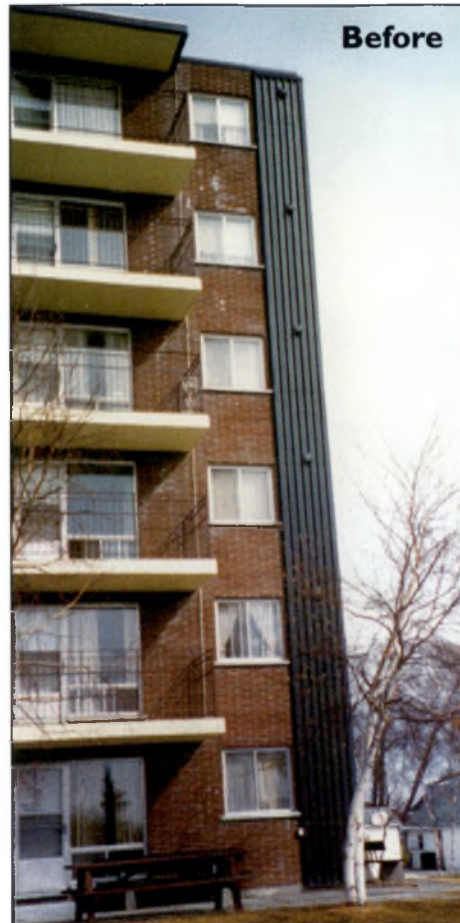
Before

The building was not energy-efficient. In fact, the exterior wall system was a source of heat loss due to the lack of an air barrier. The existing walls were 150 mm through-the-wall (TTW) load-bearing brick with 63 mm rigid insulation with gypsum board finish. The use of colour was also considered to make the building more attractive, and a unique, three-colour scheme would tie the addition in to the rest of the building.
