# Better Buildings

## Heating and hot water retrofit: Gas conversion and replacement of boilers, tank and valves

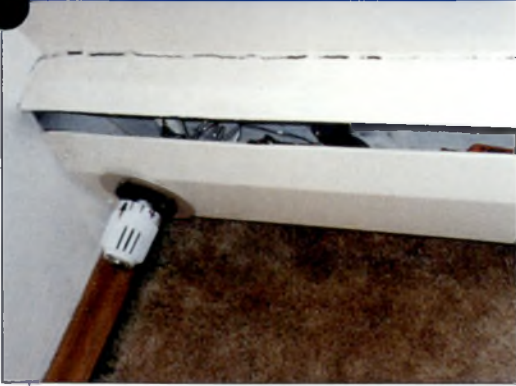
To reduce maintenance costs the contractor replaced the thermostatic radiator valves. New isolation valves were installed on either side of the new valves. Now, each thermostatic radiator valve can be isolated for servicing, and the heating system does not have to be drained every time there is a problem.

**Typical baseboard heater with thermostatic radiator valve**

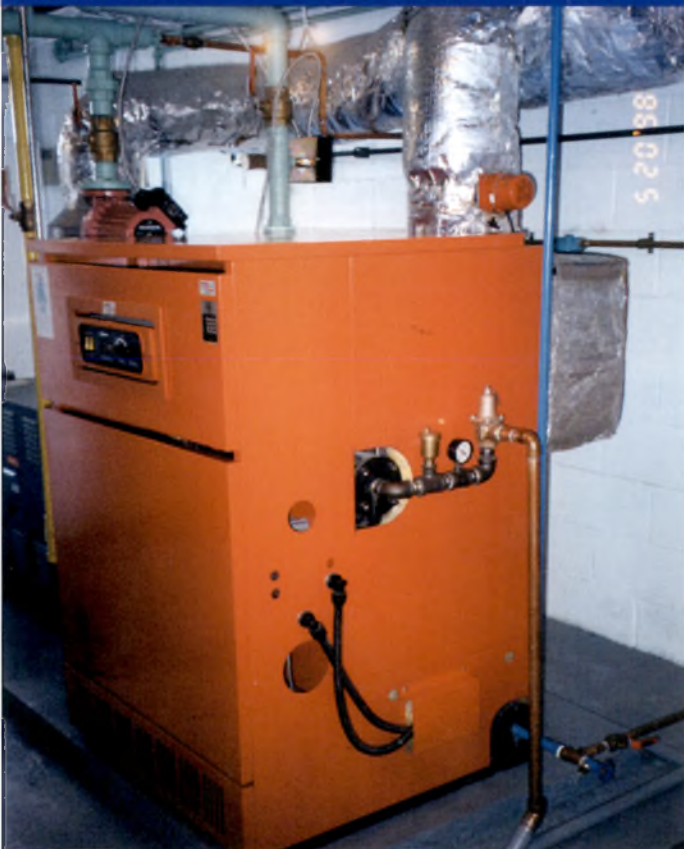
For heating, a gas fired boiler with an output capacity of 134 kW (456,500 Btu/h) and an automatic vent damper was installed and connected to the heat distribution pipes. An outside temperature control regulates the space heating boiler.

**New space heating boiler. Note the motorized insulated flue damper.**

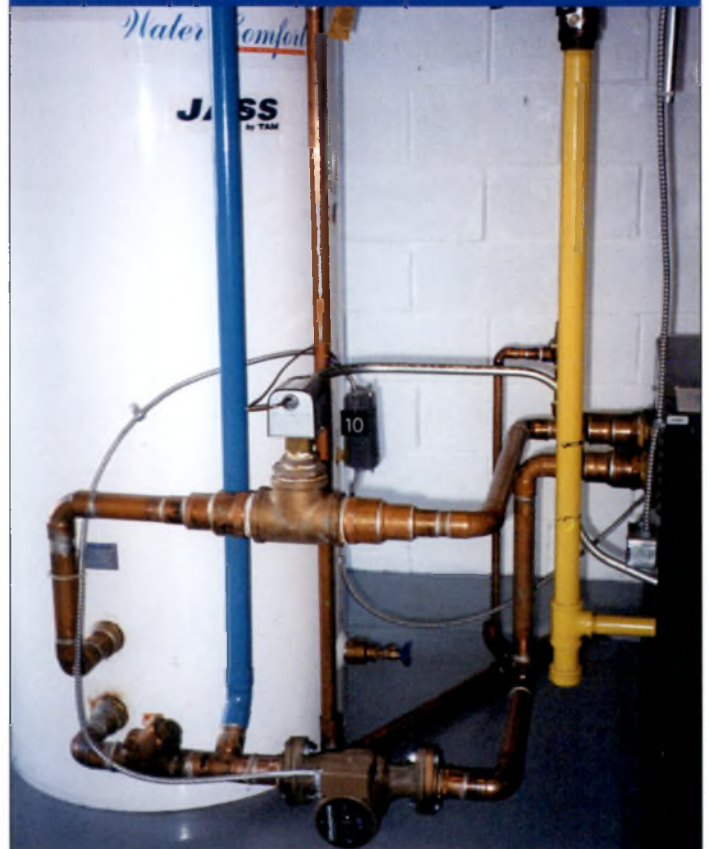
The domestic hot water boiler has an output capacity of 90 kW (304,000 Btu/h), while the new storage tank holds 454 L (100 gallons). A circulating pump and flow switch are on the pipes connecting the boiler and tank. The flow switch ensures that water is circulating through the boiler before it fires.

**New hot water storage tank and boiler (right). Note the circulating pump in bottom pipe, flow switch in top pipe.**
