Better Buildings

• BUILDING ENVELOPE SERIES •

Project: High-Rise Masonry Wall Rehabilitation

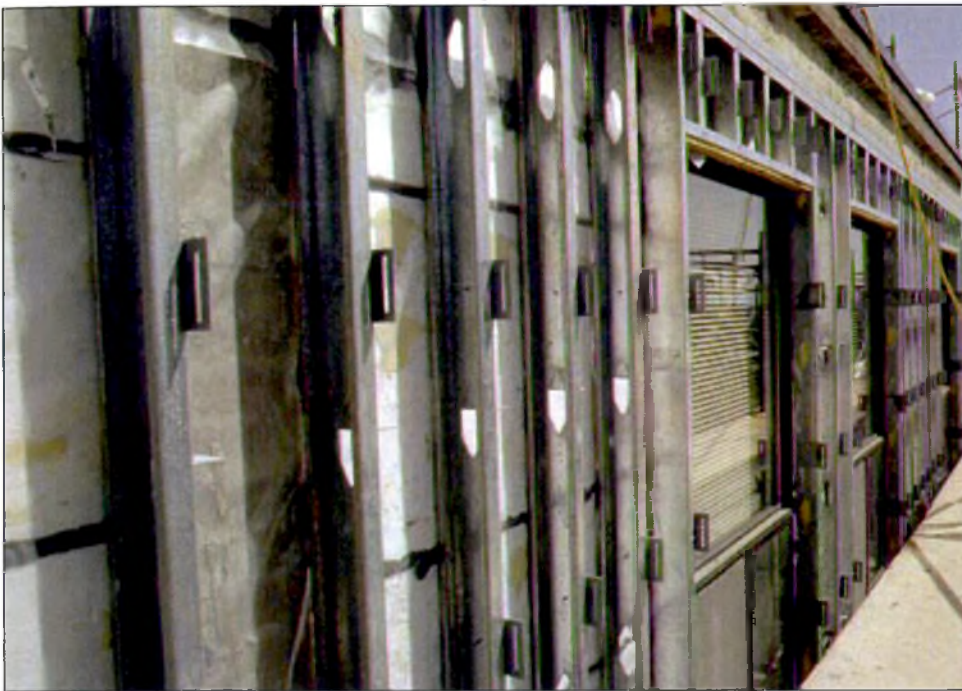
was fully occupied during the repair work, the new wall framing system had to be installed on the same day that the original wall was demolished – again, one floor at a time.

4. The crew, working from inside the units, used fasteners to secure drywall and rigid insulation to the framing system, then patched and finished the fasteners.

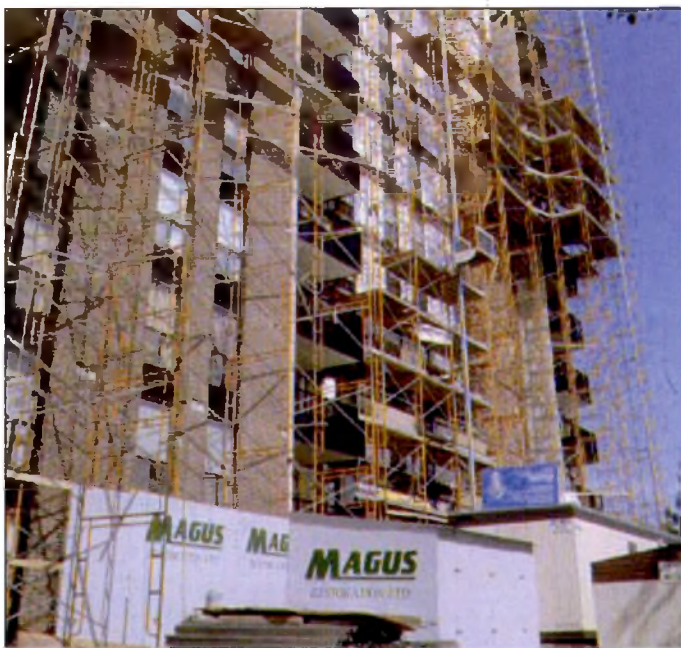
5. On the exterior, the steel stud wall system was filled with RSI 2.11 fibreglass batts and then a breathable air barrier was installed.
6. When work reached the ground level, the construction of the new brick veneer commenced, with 100-mm clay bricks being laid with a 50-mm cavity behind. Shelf angles were installed at each floor level to support the bricks.
