BETTER BUILDINGS

58 Lakeview, Timmins, Ontario

CASE STUDY NUMBER 5

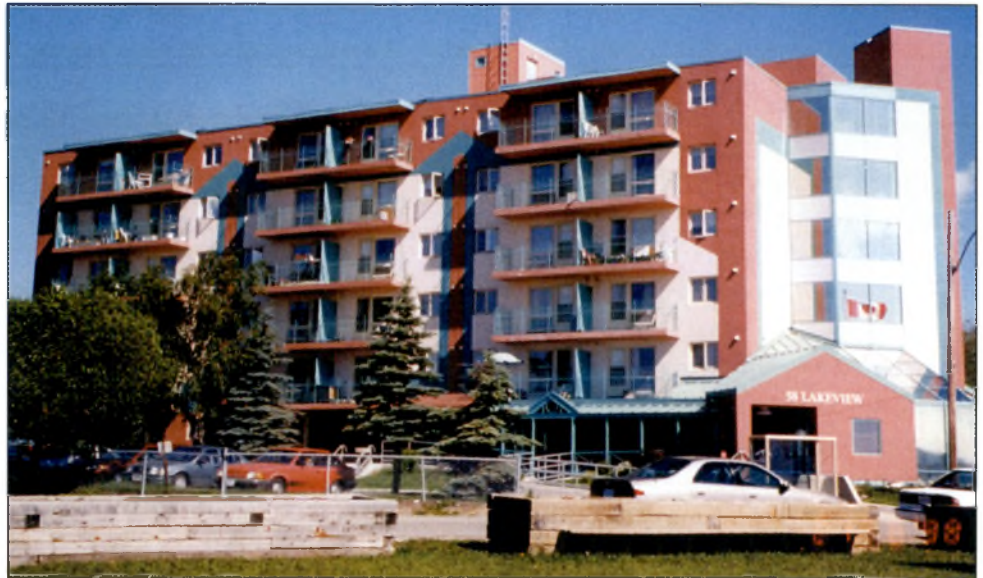
The building was not energy-efficient. In fact, the exterior wall system was a source of heat loss due to the lack of an air barrier. The existing walls were 150 mm through-the-wall (TTW) load-bearing brick with 63 mm rigid insulation with gypsum board finish. The use of colour was also considered to make the building more attractive, and a unique, three-colour scheme would tie the addition in to the rest of the building.

The 16 year-old built-up roof needed to be replaced. There were problems at the drains, serious leakage into the upper floor suites, and the insulation level was too low.

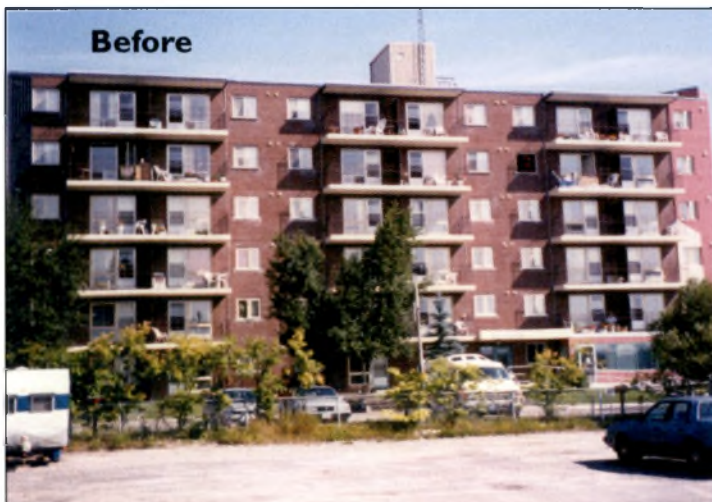
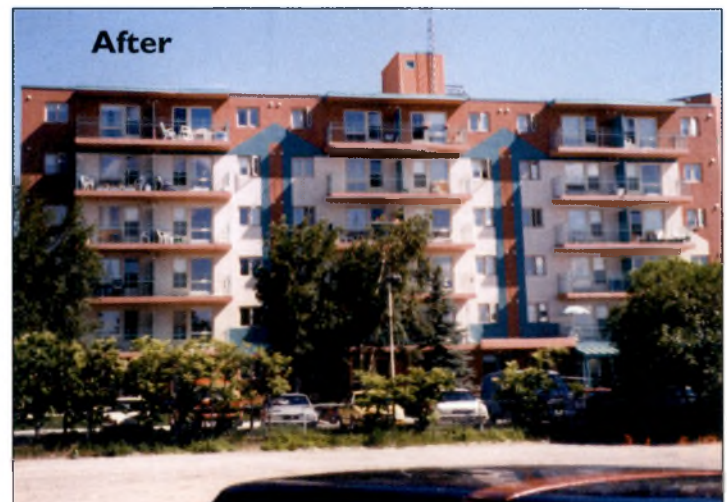
The Timmins Housing Authority has received numerous compliments on the new look of the building. The new roofing system is performing well, and the tenants find the new doors and windows easy to open.

During the first heating season after the conversion to gas, there was a record cold winter. Both the "Outsulation" system and the heating system performed well. Overall, the building's living conditions have improved. In summary, tenants enjoy improved living conditions, the heating costs dropped from \$193 to \$116 for each unit and operating costs have been reduced by 50%.
