# Better Buildings

ISSUE 2

## Parkade Ventilation Retrofit

An existing four-level underground parkade at an apartment building in Victoria, B.C. needed a new ventilation system. The “naturally ventilated” top level did not meet B.C. Building Code requirements for an “open-air storey”. Two, 25-year old, continuous-operation fan systems ventilated the bottom three levels. Residents complained for years about the noise caused by one fan, which was mounted on the exterior wall of the building. The other fan, in a small room in the parkade, was difficult to access for maintenance, had restricted air flow, and wasted storage space.

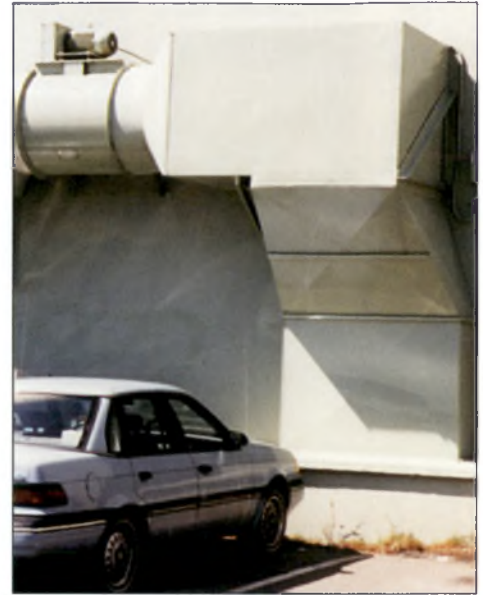
**Improved ventilation:** The under-sized supply and exhaust fans were replaced with two new exhaust fans capable of exhausting the entire parkade to 3.9 L/s per square metre of floor area (.77 cfm/ft<sup>2</sup>). The new east fan is a 10-horsepower, 36-inch tube-axial fan. The new west fan is a 10-horsepower centrifugal fan. Each system can exhaust 9,185 L/s (19,475 cfm), almost twice the capacity of the old fans.
